Figure 2-27. Typical Front Fender

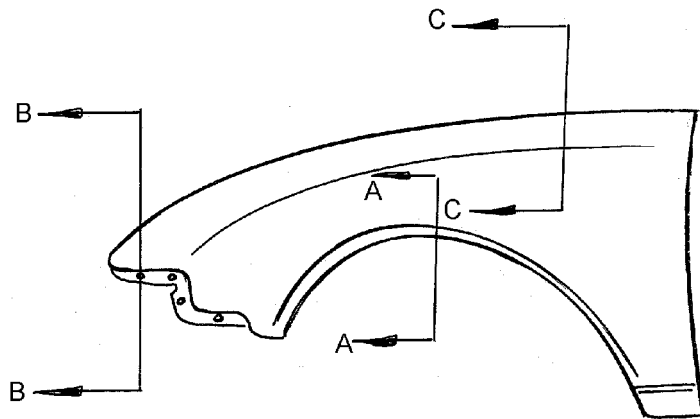
The following is an example of a front fender. The sections cut illustrate concerns when developing the trimline for this type of part.

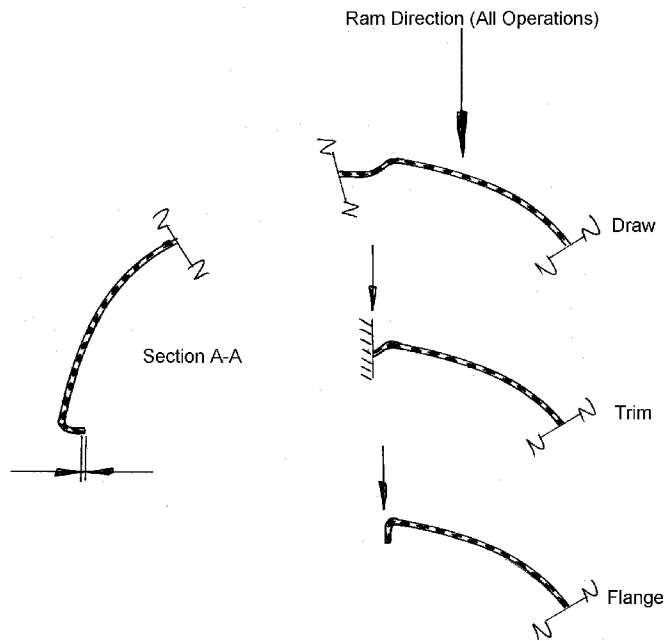
Figure 2-28. Processing Wheelarch Flange on a Fender

Section A-A

This section is across the wheelarch eyebrow, and has only one bend line. If the tolerance applied to this flange is ± 1 mm, then it should be safe to develop the trimline.

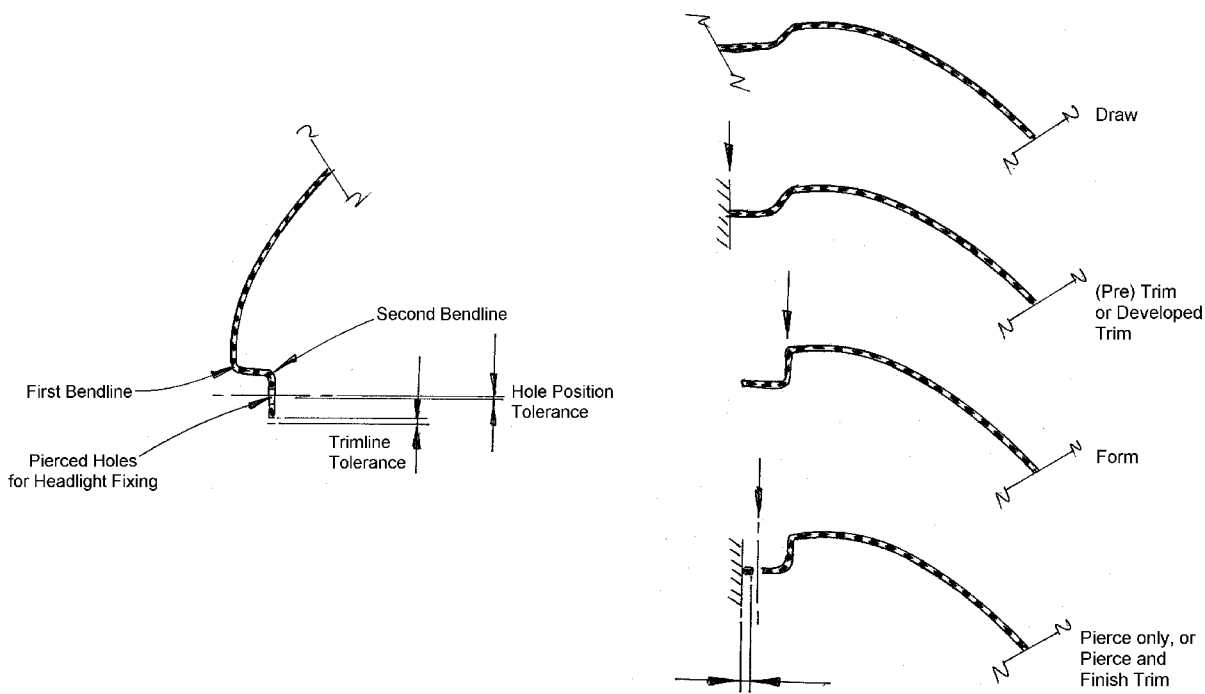
Figure 2-29.

This section is cut through the headlamp mounting area at the front of the fender. The flange is formed around two bendlines. This area will be quite critical, as the pierced holes must mate accurately with the headlight cluster, and this will be reflected in the applied tolerances. Therefore, these holes in the part should be produced in a pierce operation after the rebated flange has been fully formed. However, in order to restrike the area into the correct shape prior to trimming, it may require a pre-trim to remove excess scrap and allow the material to move into the required shape. A different tolerance may be applied to the trimmed edge, and theoretically, it is possible to attempt a development of this edge in the pre-trim die. This may be important to achieve, if the edges of the pierced holes for the headlight fixing are close to the trimline of the cutout, it could result in die maintenance problems if the trimming and piercing are combined. It could be advisable therefore, to separate these out by developing the trimline, (if the tolerance allows), final forming the rebated flange, then piercing the holes.

Processing Headlamp Section of a Fender
